Re: Target Riverdale Plaza Precast Panel Failure
WJE No. PC09.1981

At the request of Faegre & Benson LLP and Target Corporation, WJE Engineers & Architects, P.C. (WJE) has performed a limited investigation to opine on the cause of the precast panel connection failures at the Target store T1798 located in Bronx, NY. This letter serves as our report on this matter.

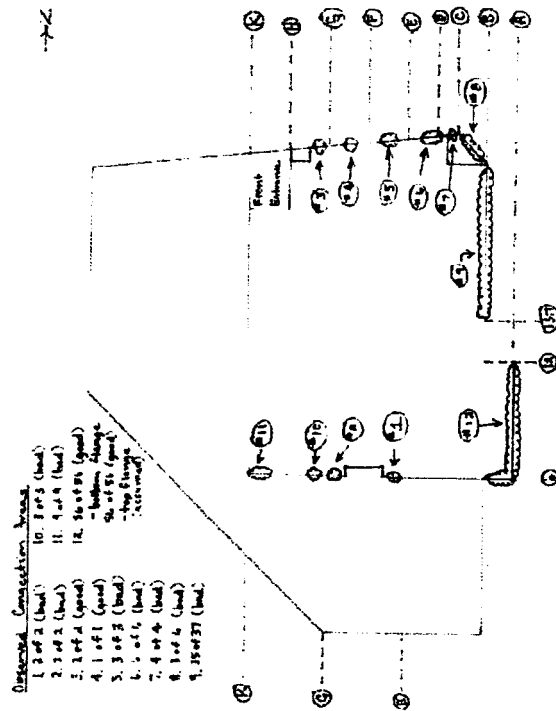
Figure 7- Location and Quantity of Broken Connections from AET Report

In January 2009, Target hired American Engineering Testing Inc. (AET) to perform a condition assessment of additional precast connections on all elevations of the Target building. AET's investigation revealed that 65 of the 75 "type 62" connections reviewed were found to be severely damaged, to the point where they could no longer provide any resistance to lateral loads. Figure 7, from AET's report dated February 12, 2009, shows the location of the connections inspected and their conditions.

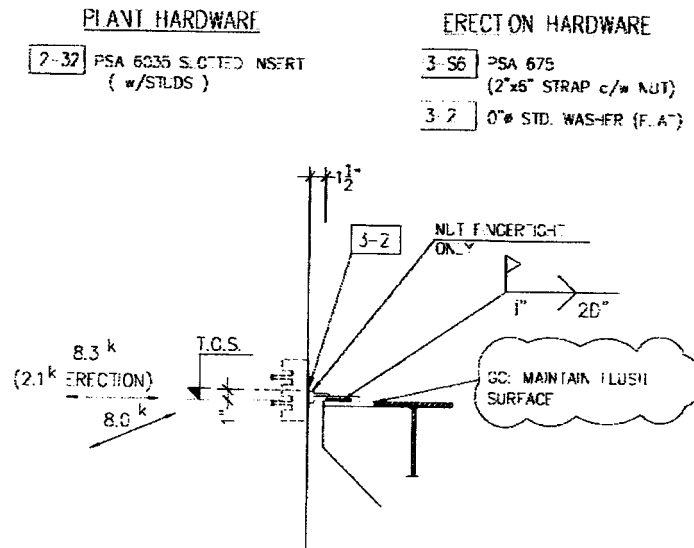
Figure 8- Typical Connection "Type 62"

Connection "type 62" is a slotted insert connection that is cast into the back of the precast panel. It is manufactured by PSA. To provide a lateral connection back to the steel frame, a threaded rod/weld plate is welded to the top flange of the steel spandrel beam and attached to the insert by a nut behind the slot (Figure 8).

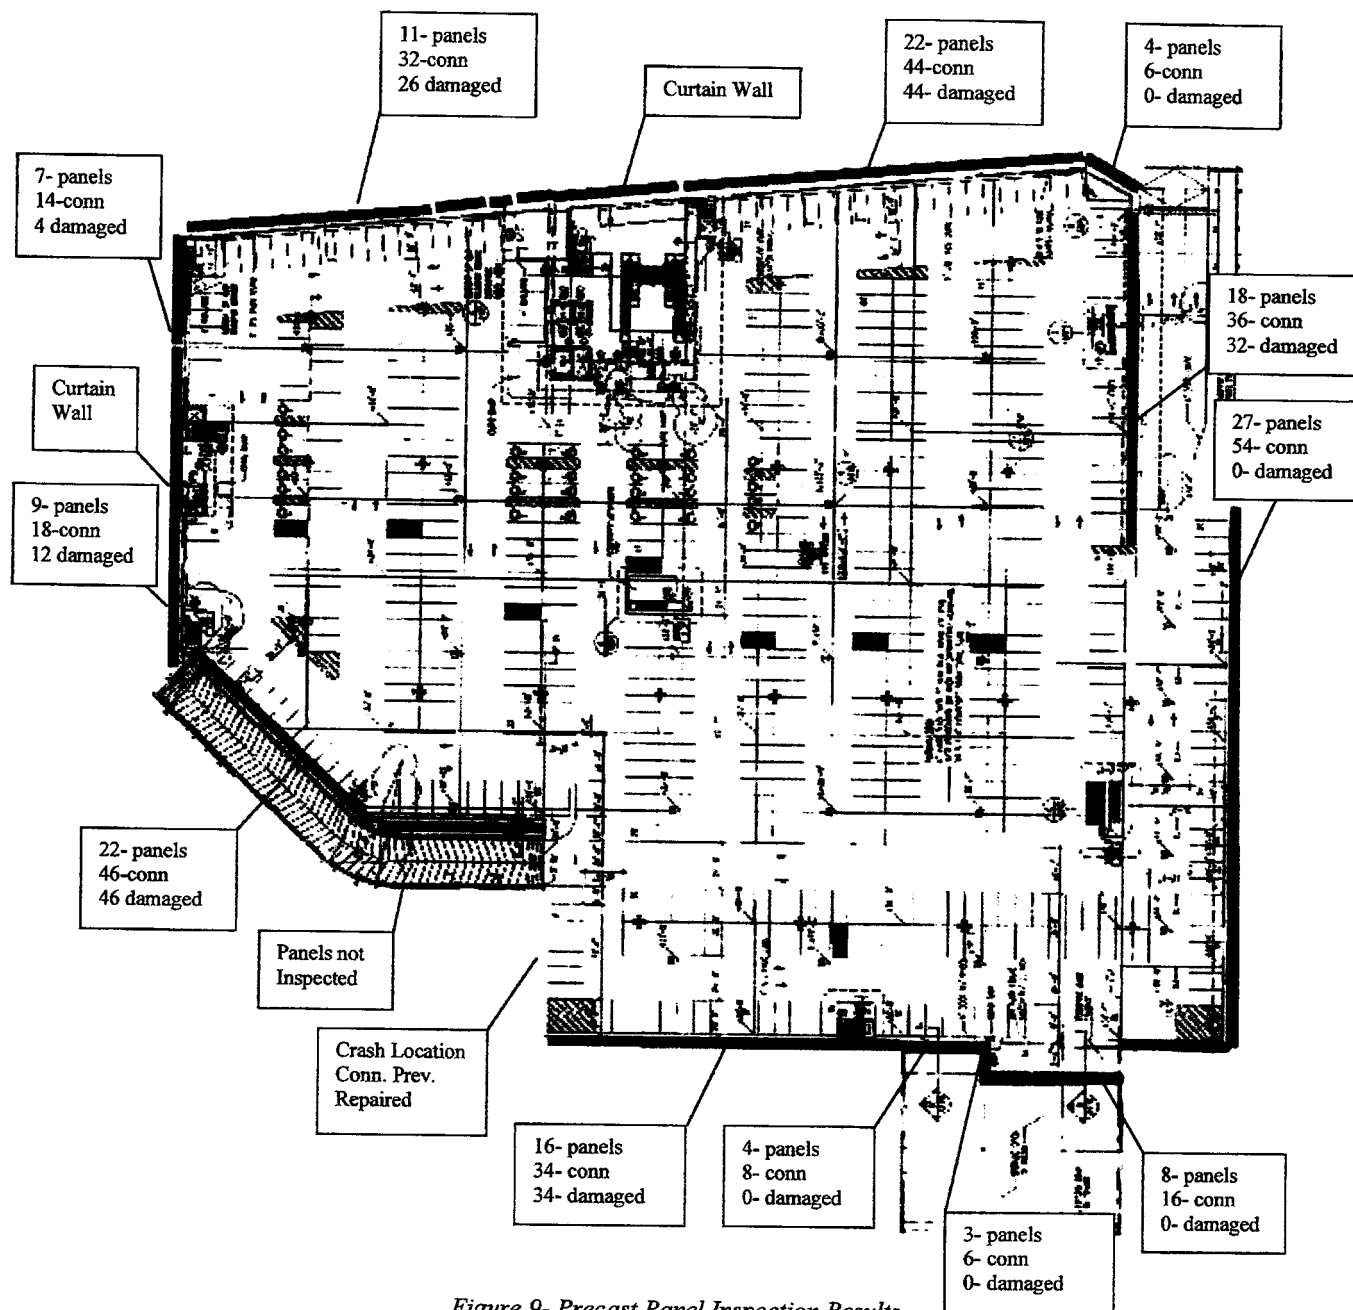
Figure 9- Precast Panel Inspection Results

On February 23, 2009, Target issued a set of drawings for an extensive inspection and repair program of the precast panel connections. Inspection of most perimeter connections was performed and documented by Schimenti Construction. Figure 9 shows the results of the connection inspections performed. 151 panels were inspected and of the 314 top panel connections, 63% of them were found to be broken.

Further evidence of slab expansion is provided by the modified calculations above and the visual evidence of no gap between the topping slab and face of the precast panel observed by both WJE and TT. Additional evidence of slab expansion is provided inside the bulkheads where the expanding slab is displacing the CMU walls on the interior at the topping slab elevation and at the guardrail posts where the expanding slab has bent every post in the direction of the slab movement. The quantity of broken connections and the fact that connections have been damaged on all four sides of the building indicates that the expanding slab is causing the failures. As shown in Figure 9, most of the perimeter precast panels connections have failed. At areas where the precast panels have short slab spans due to their close proximity to expansion joints (southeast corner and east ramp) none of the connections were found to be damaged. Removing these panels from the total count, there are 109 perimeter panels and 230 top connections of which 86% were found to have failed.

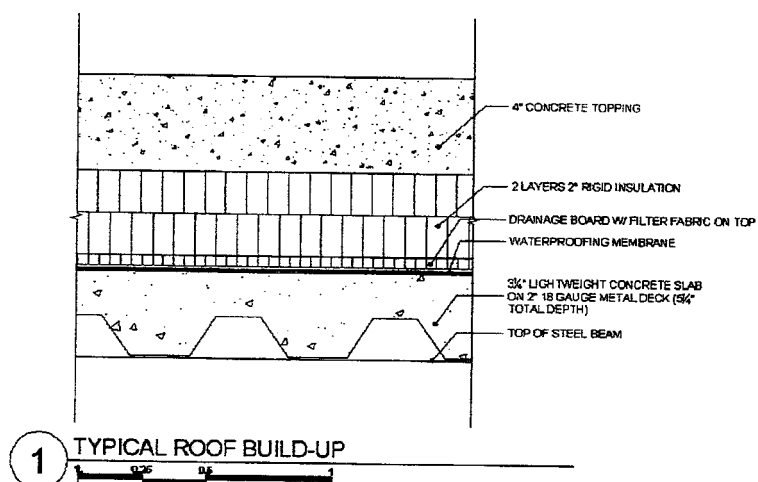
followed by two layers of 2 in. rigid insulation (4 in. total) followed by 4 in. concrete topping slab and 6 in. curb at the edges (Figure 21). At the northeast corner, WJE observed a location where an opening in the topping slab and curb was made adjacent to a section of curb/slab remaining in place. The section remaining in place could be viewed from the side (Figure 22). An approximate 1 1/2 in. gap was observed between the edge of the structural slab and the face of the precast panel. The waterproofing membrane turned up the face of the precast panel approximately 1 ft. as shown in the design drawings and terminated with a termination bar. The filter fabric and drainage mat terminated at the precast panel and did not turn up the wall (Figure 23). The construction largely comports with the architectural drawings except as follows: A drainage mat and filter fabric were used in lieu of the protection board shown in the drawings and two layers of Extruded Expanded Polystyrene rigid insulation (DOW blue board) were used. The concrete at the edges was cast up against the precast panels with a piece of fiberboard between the precast panel and edge of slab. The curb was then cast on top of the topping slab as opposed to being cast monolithically next to the edge of the topping slab as shown in the drawings. Also, the steel curb edge specified in the drawings was not installed.

Figure 21- As Built Roof Build-Up

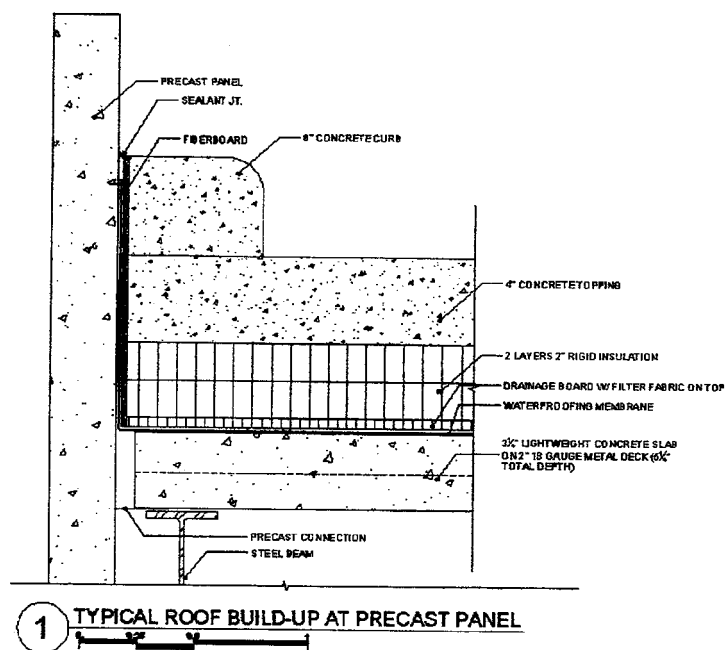
From this view, WJE observed that there was no gap cast between the edge of the topping slab/curb and face of the precast panel. Only the waterproofing membrane and an approximately 1/2 in. thick piece of fiberboard separated the slab edge from the precast panel face. Furthermore, a lateral displacement between the two layers of rigid insulation was observed.

Figure 22-Roof Build-Up as Observed by WJE at Precast Panel
